# Managing Infrastructure Problems That Arise From Earthquakes

ALMA M. RICHIE, *Utah Division of Public Utilities*

This article is a compilation of information on infrastructure problems that arise from earthquakes. It outlines the measures needed to determine what went wrong during such disasters and how to prevent future problems. Understanding the effects of earthquakes can help make the infrastructure safer and less prone to damage.

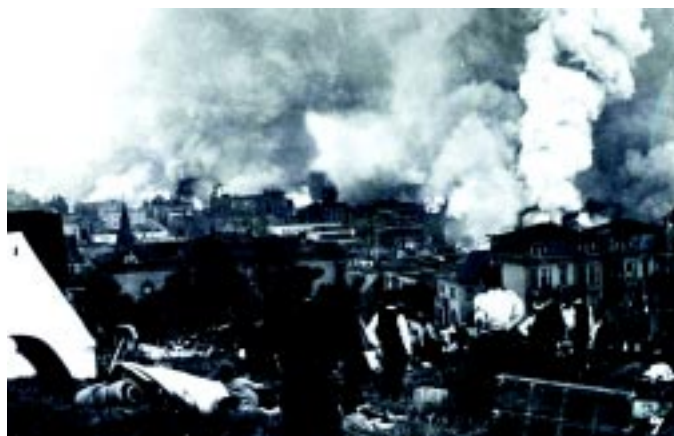
**FIGURE 1**

San Francisco in flames after 1906 shock. Fire-fighting efforts were hampered by the unavailability of water, a consequence of the many major pipeline breaks that were caused by ground failures. Photo courtesy of the P.E. Hotz Collection, U.S. Geological Survey (USGS).

streets. One important characteristic of the shaking intensity noted in Lawson's (1908) report<sup>5</sup> is the clear correlation of intensity with underlying geologic conditions. At the Valencia Street location, the earthquake caused a settlement of from 6 to 8 ft (2.4 m) for a distance of from 150 to 200 ft (46 to 61 m) along this street. It simultaneously shifted the entire street, with adjacent lands, eastward through a maximum distance of 9 to 10 ft (2.7 to 3 m). This change in alignment and grade could, of course, mean nothing less than the total destruction of all water and gas mains, electric lighting and telephone conduits, sewers, cable conduits, railroad tracks, etc. The destruction of the water lines totally cut off water to a large portion of the city that soon was engulfed in flames (Figure 1).<sup>6</sup>

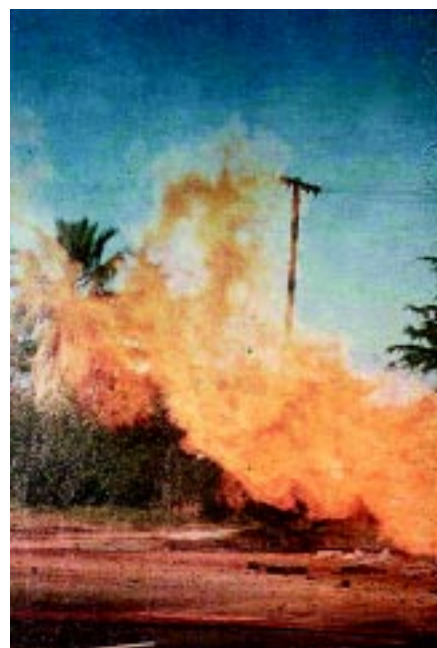
**FIGURE 2**

1971 San Fernando, California, earthquake where utility lines—gas, water, sewer, telephone, and electricity—were disrupted in the areas of most intense ground motion. Gas and other pipes failed where they crossed the zones of surface faulting. Photo courtesy of the USGS.

ing was recorded as a thrust. Craters from gas line breaks and flooding from water line breaks occurred following ground displacement beneath the San Fernando Juvenile Hall. During liquefaction, the induced lateral spreads caused pipes to suffer the greater damage.<sup>7</sup> Death and injury in an earthquake are caused primarily by partial or total collapse of man-made structures. Gas, water, sewer, telephone, and electricity lines were disrupted in the areas of the most intense ground motion (Figure 2). Pipes that failed crossed through the zone of surface faulting

(Figure 2).<sup>8</sup> Both California Governor Ronald Reagan and U.S. President Richard Nixon declared San Fernando a state of emergency and a national disaster.<sup>9</sup>

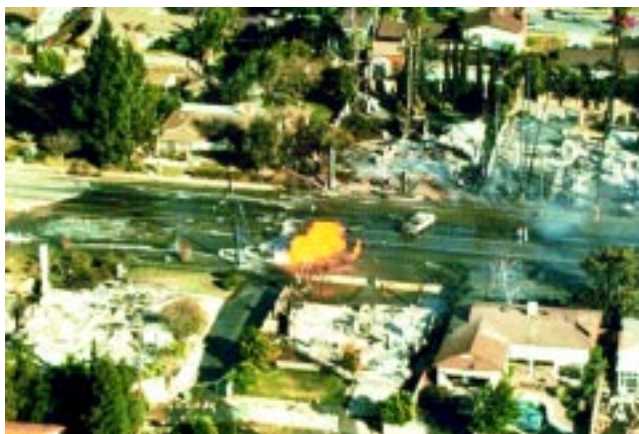
FIGURE 3

Both gas and water pipes burst beneath Balboa Boulevard north of the Simi Valley Freeway from the force of the main shock, creating this bizarre and destructive combination of fire and water. Photo © copyright Kerry Sieh, California Institute of Technology. Photo reprinted with permission.

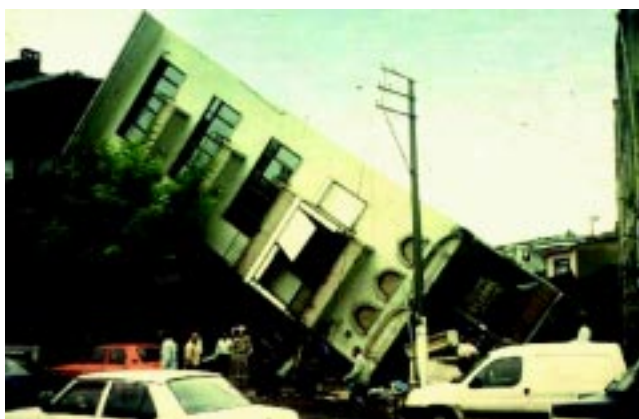
FIGURE 4

Tipped building in Adapazari, Turkey, caused by liquefaction-induced loss of bearing strength during the 1999 Kocaeli, Turkey earthquake. Photo courtesy of T.L. Youd.

A devastating earthquake (M 7.4) occurred on August 17, 1999, in Kocaeli, Turkey, which is ~50 miles (80 km) southeast of Istanbul (Figure 4). A 2.2-m-diameter ductile steel water pipeline (ATI, API Grade B, mild structural steel)<sup>12</sup> crossed through the fault at a location where 3 m of fault displacement occurred. Although it was severely deformed, it continued to supply water after the earthquake. The Kocaeli earthquake provided a good example of how longitudinal compression affects pipelines. Longitudinal compression has been shown to be one of the most common causes of earthquake damage to pipelines. Once again, Youd cautions: "It is important to avoid, if possible, putting critical structures through the fault line. By learning from failures, improved con-
